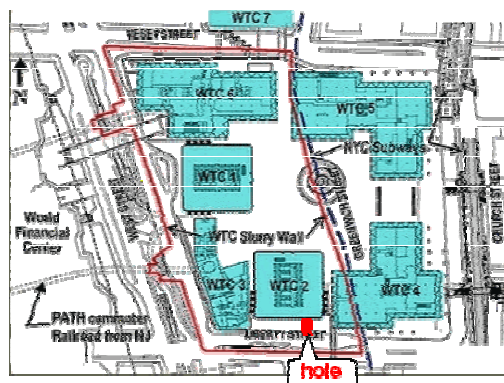
Figure 18. This hole adjacent to WTC2 (zone 2 in Figure 303(c)) is through sidewalk and pavement. This hole contains more debris than the hole discussed in Figure 300 above. It looks as if the debris fell in the hole. Note the scale, shown above. *(photo filed 9/21/01)*

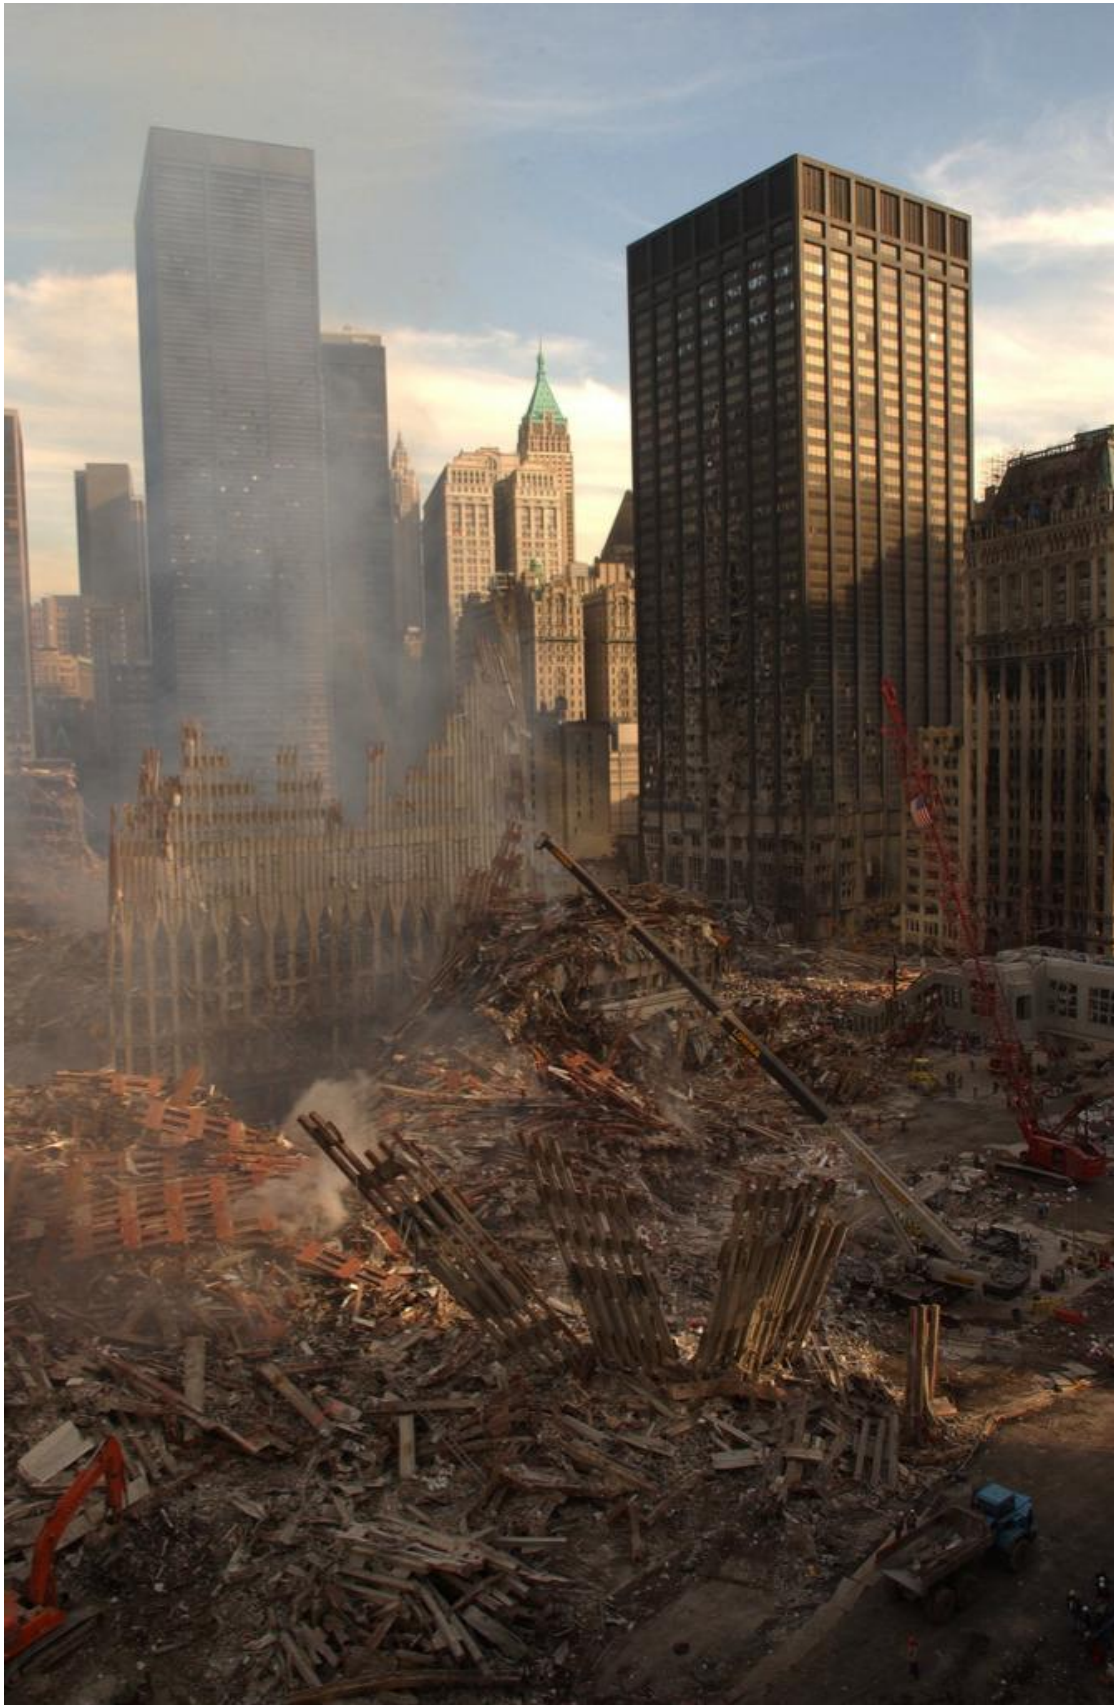
Figure 19. The three steel wheatchex stabbed into West Street in the foreground and the remains of WTC3 in the background, in front of the west wall of WTC2.

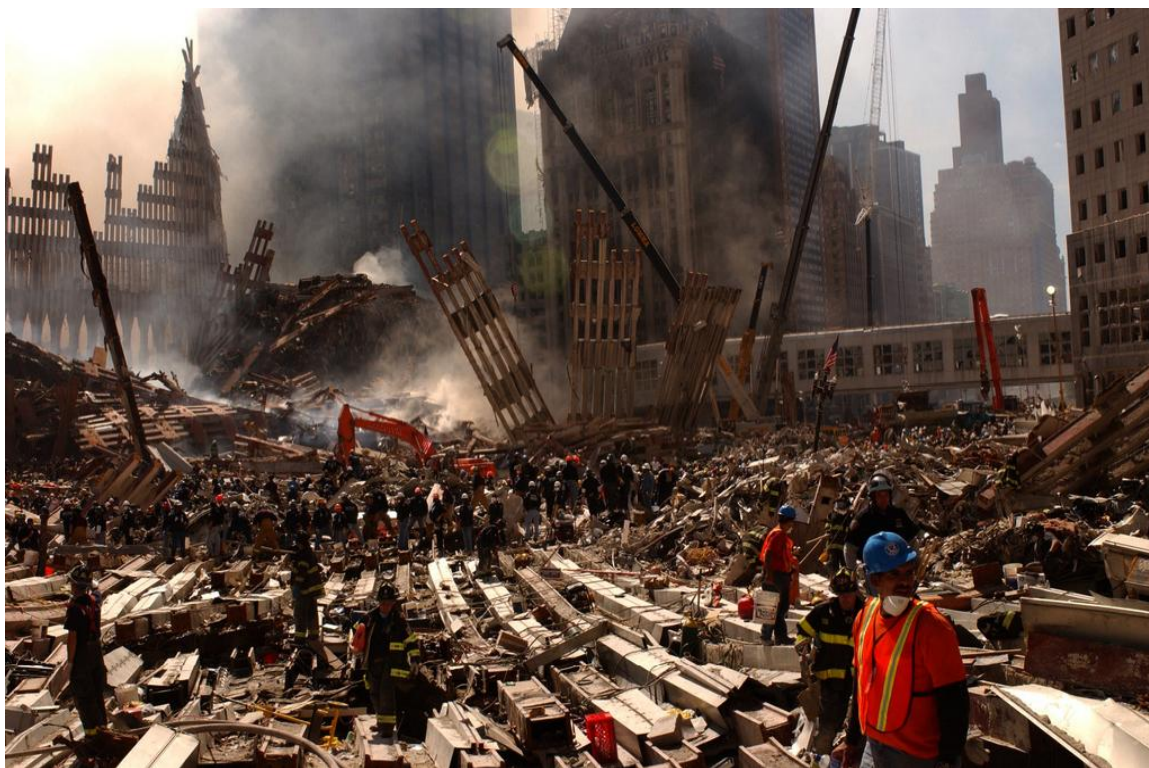
Figure 20. The remarkable "lay down" of steel wheatchex from the lower stories of WTC1 on West Street (West Side Highway). The WTC3 debris pile is in the background, next to the unsupported WTC2 wall. (9/13/01)

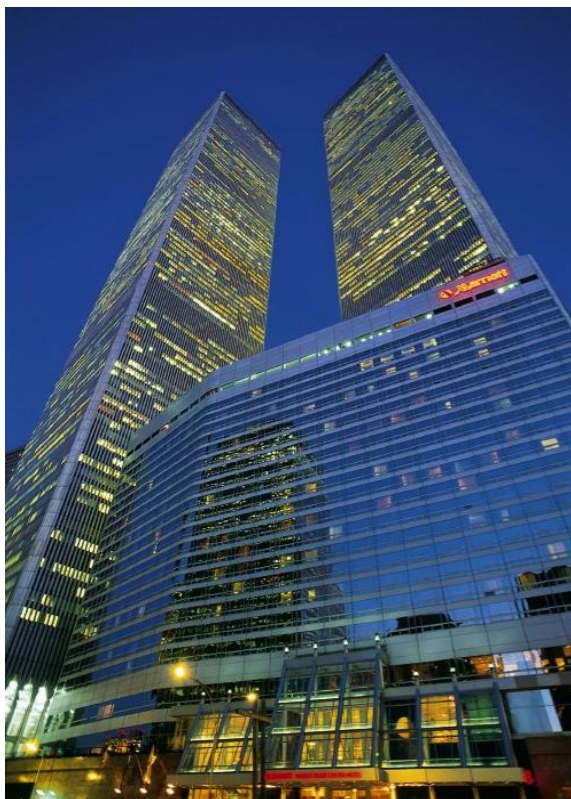
Figure 21. Here is a reminder of the material that must be accounted for in the rubble pile. Viewed from West Street.
